## TEST REPORT

No. : XMIN191002543CCM

Sample Name : EPDM RUBBER 2

Test Item: Major Composition Qualitative Analysis

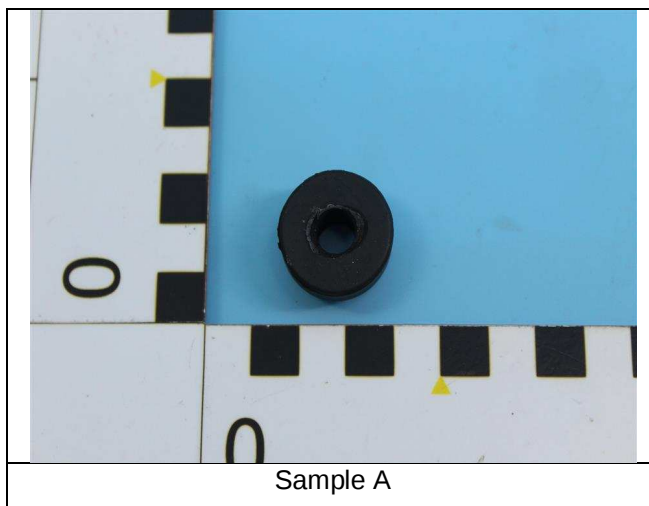
Sample A

### Original Sample Photo:

Sample Description: Rubber part

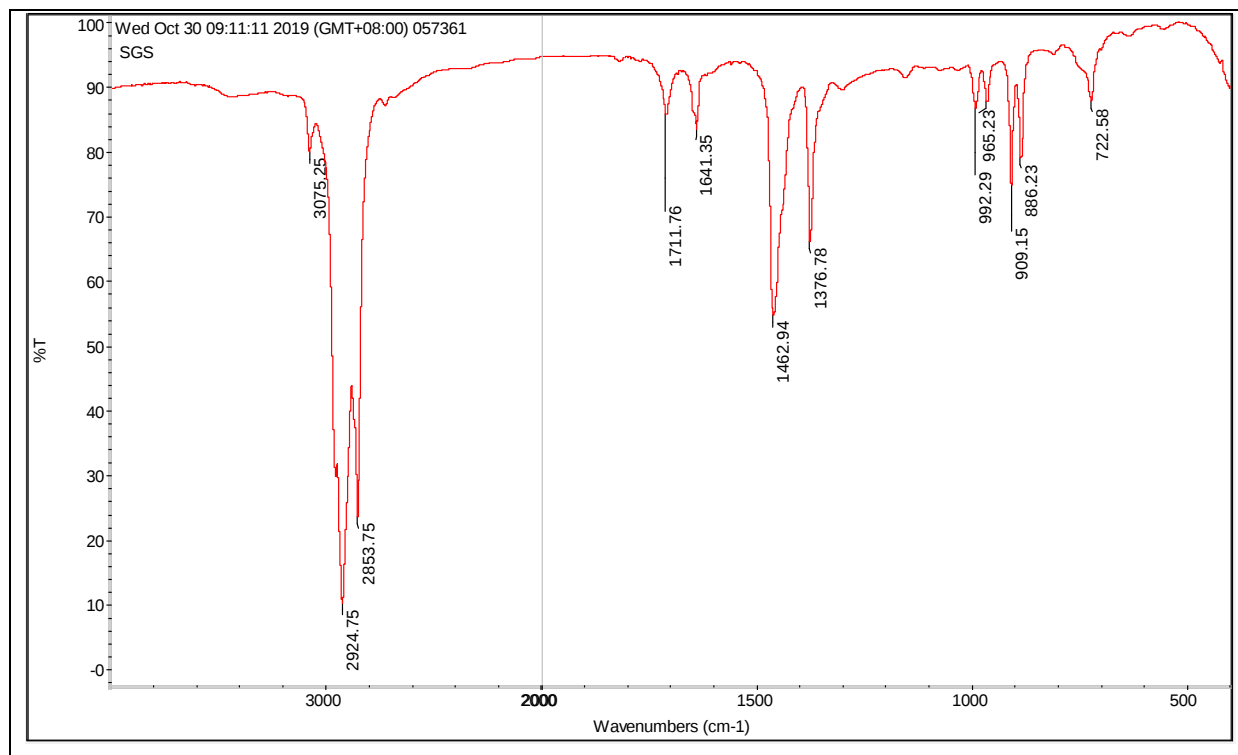
Fig.1

Test Method: GB/T 7764-2017, analysis was performed by FTIR.

| Sample | Major composition |
|---|---|
| A | Ethylene-propylene-diene monomer(EPDM)<br>(FTIR spectrum see Fig.1) |
